Manhole Inspection Summary

Manhole # S39G__043MH

Insp Date: **2/20/09 11:34 AM**

Location Address: **1023 WATSON ST**

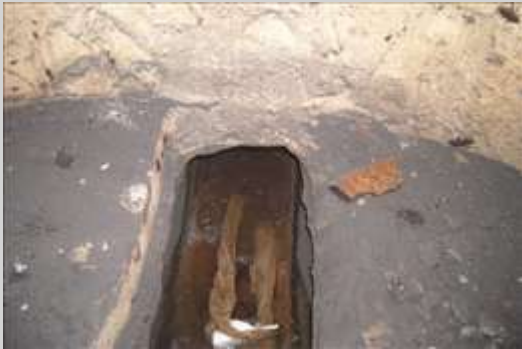
12 O'Clock Outflow

Pipe Height: **9.6** (in.) Rod and Bar (Angled)
Pipe Material: **Clay** ☐ Pipe Lined
Invert Depth: **9.96** (ft.) Flow Characteristics: **Slow**
Deposits: ☒ None ☐ Mud ☐ Sludge ☐ Debris ☐ Grease
Silt Depth: **0** (in.) Deposits Extent:
Infiltration: **None** Pipe Seal Cond: **Sound**
